Flood Investigation Report

Portesham
19th January 2019 Event

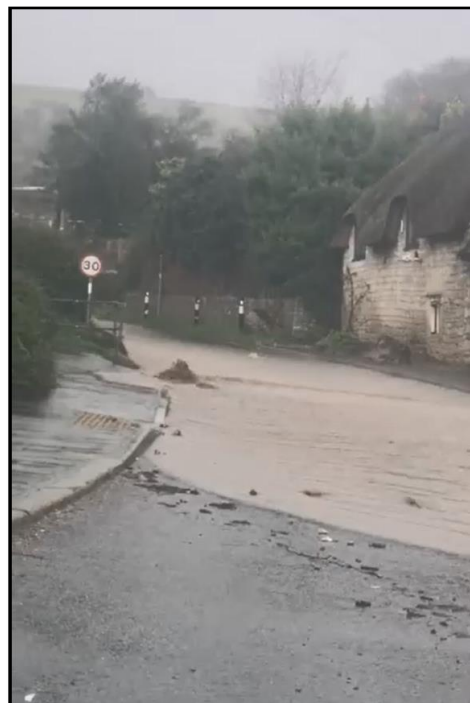
Photo 1 – Front Street looking north towards Portesham Hill

The highway drainage system was unable to cope with the volume and velocity of the flood water. Photo 1 shows the highway drain surcharging and flowing along Front Street. A portion of the flood water entered the watercourse that flows south on the western side of the carriageway. However, footage of the incident shows the watercourse overtopping back onto the road on the upstream side of several culverts.

The sluice gate, that offtakes the stream via a culvert under Front Street to the elevated eastern channel, was locked and in the shut position. Residents and members of the Parish Council were unable to open the gate to allow additional flows through this channel. Opening the sluice gate during the event could have reduced the flooding experienced in Front Street. Although the impact would have been limited given the restriction of the culverted section under the highway. However, it does identify the need to have a management plan in place to enable the sluice gate to be opened during high flows.

After the sluice gate, the western channel becomes elevated, with the bed of the stream almost level with the highway. The watercourse overtopped at this location, flowing back onto Front Street. One property flooded here due to obstructions within the channel.

Improving the maintenance of the watercourse would increase the capacity of the channel and reduce the risk of blockage, reducing the flood risk. Alterations to the channel to remove permanent blockage risks, such as low bridges, would also have a positive impact on flood risk upstream. However, the downstream effects would need consideration.

It is recognised that improved maintenance of Portesham stream is needed to reduce flood risk from future high rainfall / groundwater events, this is problematic as the responsibility is shared between a large number of parties. It is recommended that a community approach is implemented, in which responsibility for maintenance of the watercourse is shared between all members of the community, rather than just those with riparian ownership responsibilities.

The silt, sand and gravel that originated from the hills to the north, resulted in the blocking of highway gullies and increased the silt load in the watercourse. To reduce this, it is recommended that the LLFA explore whether there are any Natural Flood Management interventions that could slow/divert the run off from the hills and reduce silt deposition. This could be in the form of silt traps at field boundaries or cross drains on farm tracks. This could help reduce the amount of silt that is entering the highway drainage systems and reduce the silt build up in the watercourse.

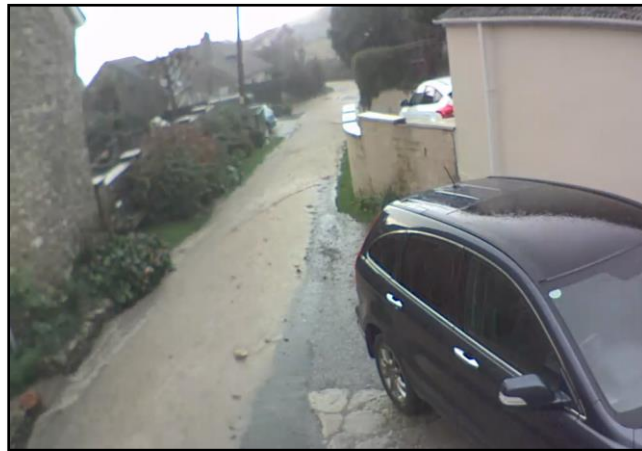
Photo 2 – Rocky Lane looking west towards Front Street

Overland flows from the surrounding hills were conveyed via a farm track and Right of Way (RoW), bringing with it a significant amount of silt and gravel. A soakaway was installed at the entrance to the RoW, however it was situated higher than the footpath.

During the flood event flows were unable to enter the system, although the soakaway would not have coped with the volume of surface water experienced during the event.

A section of Rocky Lane was recently tarmacked. While this has improved the surfacing of the Bridleway, it has unintentionally resulted in surface water run-off increasing in velocity. Residents have stated that the camber of the highway changed as a result, and now the bridleway channels surface water towards the properties on the southern side of the Lane. One property experienced internal flooding during the event. There are several small ditches and culverts that run along the southern edge of the bridleway that intercept springs along the track. However they are not designed to cope with an extreme rainfall event.

It is recommended that Natural Flood Management interventions are explored to divert/reduce the amount of overland flows from the surrounding hills that are conveyed onto Rocky Lane. Further investigation is needed into the current drainage arrangements installed by RoW. It is also recommended that property level resilience and/or resistance

measures are considered in properties at risk of flooding. Riparian owners are also advised to ensure that ditches and culverts are maintained and offer unobstructed flow.

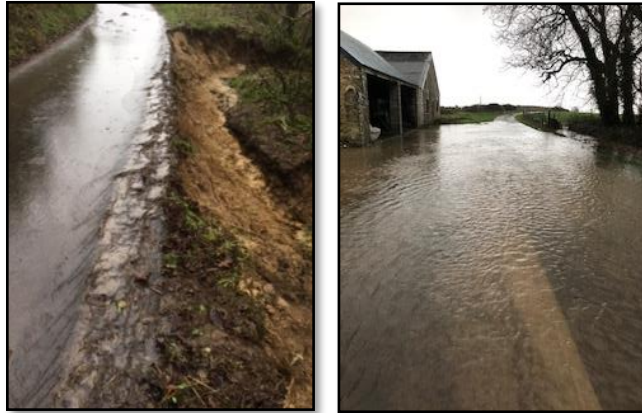
The extreme rainfall led to overland flows flooding the external buildings of Portesham Farm. The farm track then acted as a conduit for the flood water, this led to localised land slippage of the track. The mud and debris from the slippage mixed with the exceedance flows which resulted in the flooding of Winters Lane.

A portion of the surface water on Winters Lane discharged into a culvert along the back of properties in Winters Close. Most of the exceedance flows were conveyed onto Front Street, and towards Goose Hill. The mud and debris contributed to the highway gullies blocking along Front Street and the B3157 Coast Road.

Photo 3 – Bank collapse and flooding at Portesham Farm

It is recommended that the LLFA explore whether there are any Natural Flood Management interventions that could slow/divert the run off from the hills and reduce silt deposition. This could be in the form of silt traps at field boundaries or cross drains on farm tracks. This could help reduce the amount of silt that is entering the highway drainage system. There are several smaller ditches and culverts that run along both sides of the highway that intercept spring water along Winters Lane. These culverts would not have coped with the extreme rainfall, however some are currently blocked, resulting in spring water flowing across the highway in normal conditions. Although they did not contribute significantly to the flooding experienced, it is recommended that these culverts are repaired and maintained to enable the free flow of water. This will also decrease the risk of ice forming across the highway during the winter months.

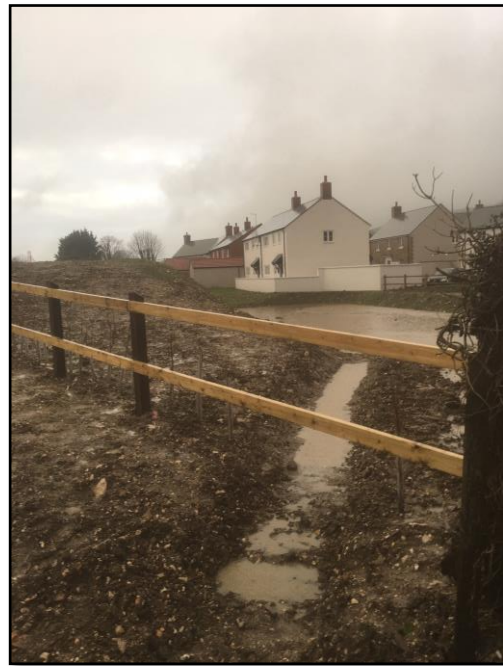
Previously this was a greenfield site with a history of flooding. During the 2012 flood event, the field flooded and a cut through was made in the redundant railway embankment to relieve the flood risk to the adjacent Village Hall. This cut through was accepted as part of the existing drainage characteristics of the site when the site was developed.

During the event, the culvert under the railway embankment coped with the additional flow, with photos showing that it was at approximately 75% capacity. However, silt build up and obstructions in the watercourse downstream of the culvert caused flows to come out of bank, resulting in property flooding. To alleviate this, the weir on the upstream side of the culvert was lowered to allow more flow into the attenuation pond. This reduced the impact of the watercourse downstream coming out of bank but filled the attenuation pond more quickly. However, it did not overflow onto the highway on this occasion.

**Photo 3 - Cut through at
Malthouse Meadows**

It is recommended that the watercourse is cleared of silt and obstructions to enable a free flow of water. Shortly after the event the watercourse downstream of the railway embankment was de-silted and obstructions removed. This needs to continue in conjunction with the full length of the watercourse and this could form part of the wider Flood Action Group initiative. There is a Management and Maintenance Plan in place for the development site and the developer needs to ensure that the plan is followed and works carried out on a regular basis to clear the watercourse around the site. With regards to the weir, this has now been constructed in brick and has been set at the level agreed by the development's planning permission.

Given the concern about the culvert under the railway embankment, it is recommended that the LLFA register this as a critical structure.

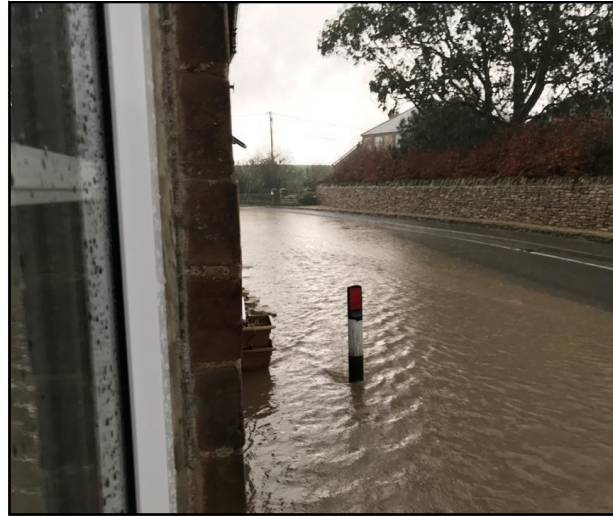
Photo 4 -Goose Hill looking west towards Abbotsbury

During this event it was reported that six properties flooded internally. Surface water and fluvial flood water flowed through the village and onto the B3157. There is an open ditch system, upstream and behind the properties along Goose Hill. At the time of the event the ditch had capacity to take additional flows. However, due to the topography and camber of the road, the flood waters bypassed this system. This resulted in the floodwater collecting against the properties and across the road.

Residents raised concerns regarding the delay of the road closure. The impact of flooding on Goose Hill was greatly exacerbated by vehicles travelling along the B3157, due to 'bow-waves' pushing flood water above thresholds and into properties. They also raised concerns about the flood alleviation scheme at the Malthouse Development site.

It is recommended that residents explore the option of flood resistance and resilience measures to their properties, and that the LLFA also explore whether there are any funding opportunities available to assist residents with these measures.

The flooding experienced was exacerbated by the bow waves from vehicles driving through the flood waters. It is recommended that the LLFA, Dorset Police and DC Highways explore road closure process for future flood events.

Given the prevailing flood risk from the surrounding area and the impact at Goose Hill, it is recommended that the LLFA and DC Highways explore a potential flood alleviation scheme to intercept flow paths. This could be achieved by directing water into the open ditch before the properties in Goose Hill. However further investigation is required with the relevant authorities to see whether this scheme would be feasible.

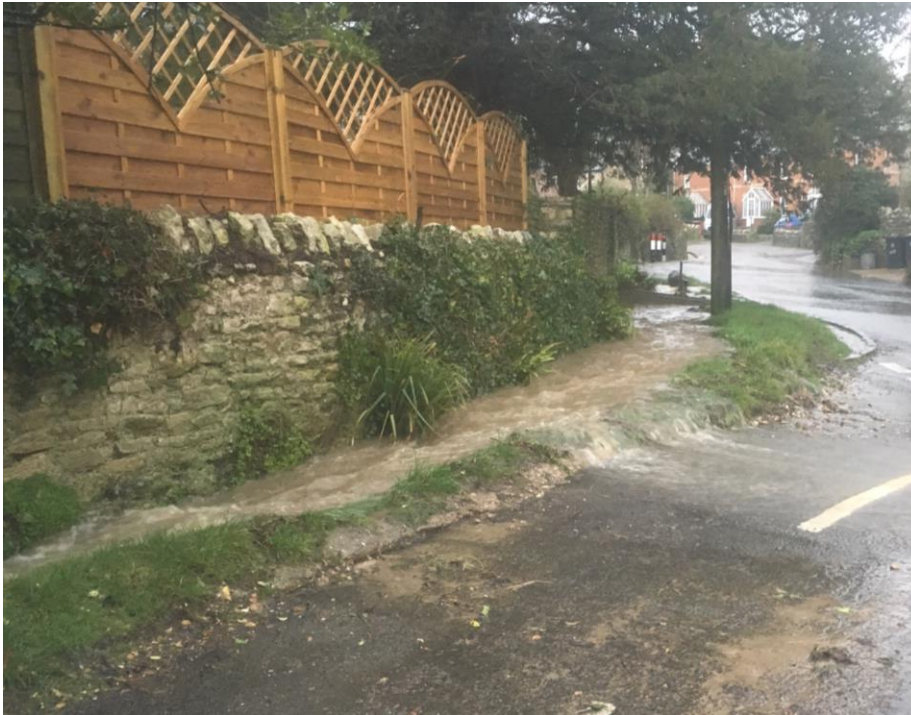
**Elevated western channel,
looking north-east towards front
Street**

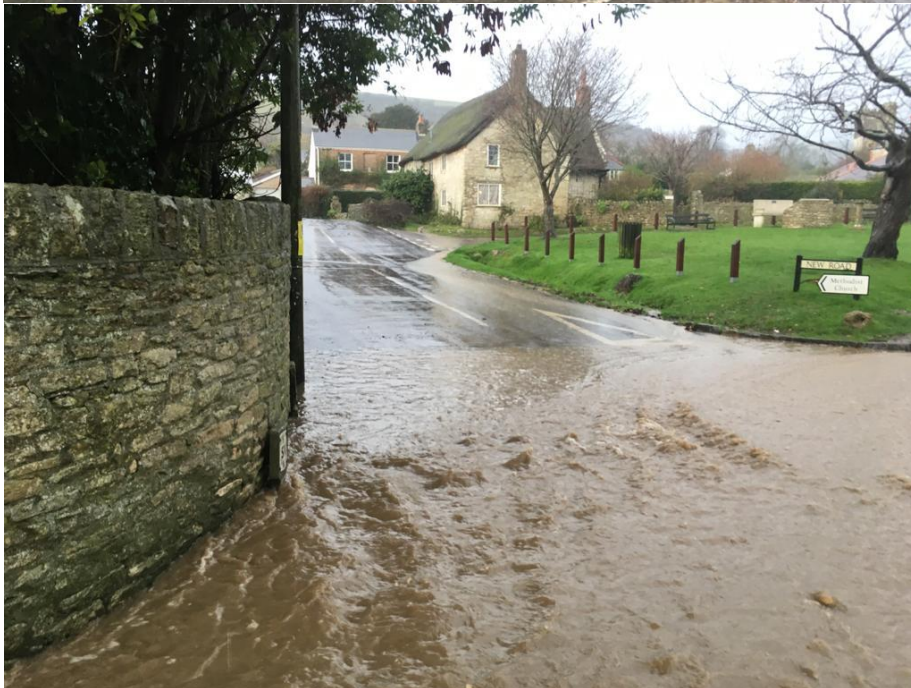
**Front Street, looking towards
New Road**

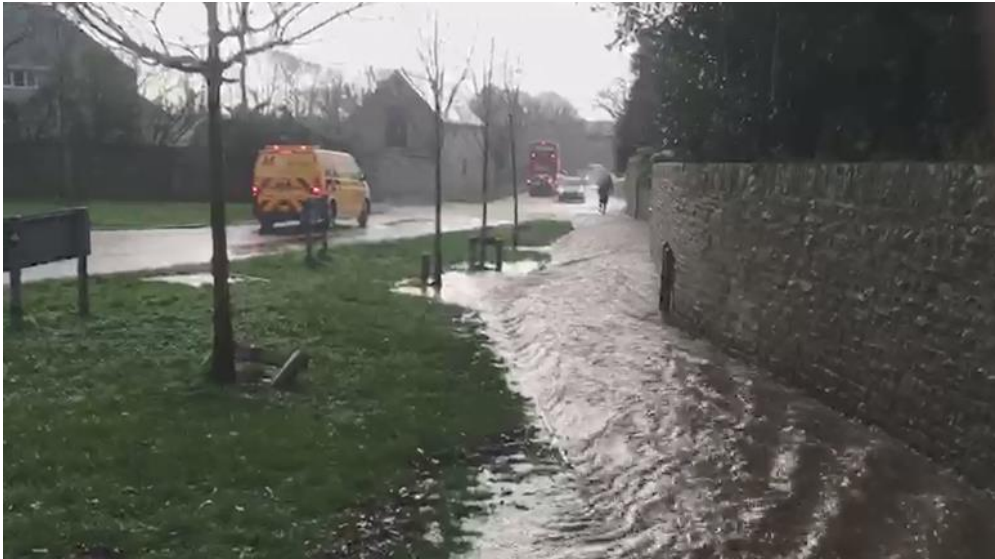
**Bottom of Front Street,
looking west along the
B3157 Coast Road**

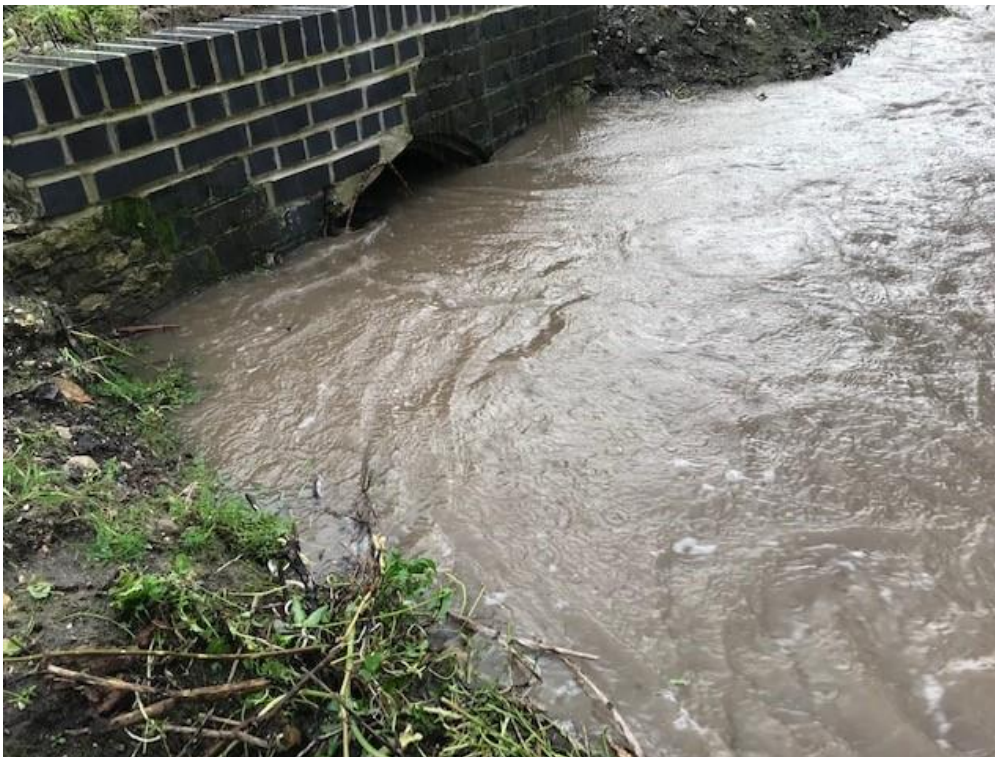
**Culvert under railway
embankment,
Malthouse Meadows**
