Portland  
energy recovery  
facility

Framework heritage  
mitigation strategy

E Battery  
East Weare  
Portland  
Dorset

Prepared by: Jon Avent  
*BSc(Hons) MStructE, IHBC, CARE  
Accredited Conservation Engineer*

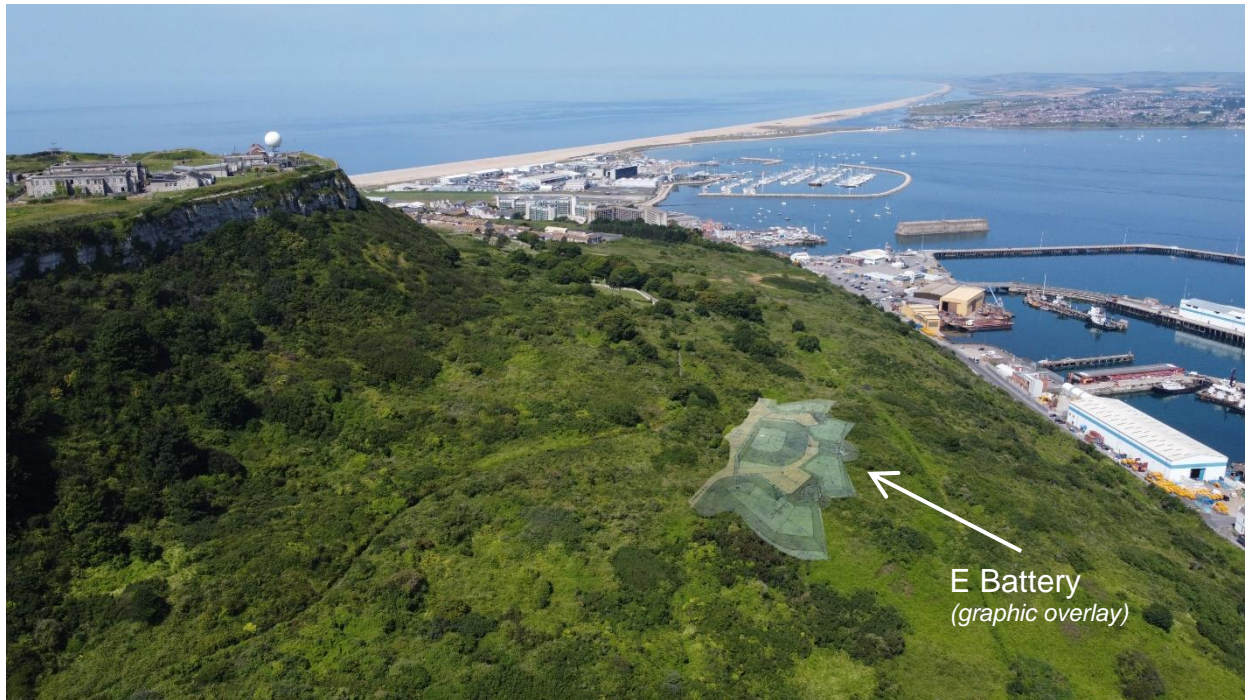
- 2.01 The image below is a view of the site of E Battery looking north west across Portland Harbour. The area of the site is heavily vegetated with the majority of the structure covered. An overlay of the approximate location and configuration of E Battery has been added for reference.

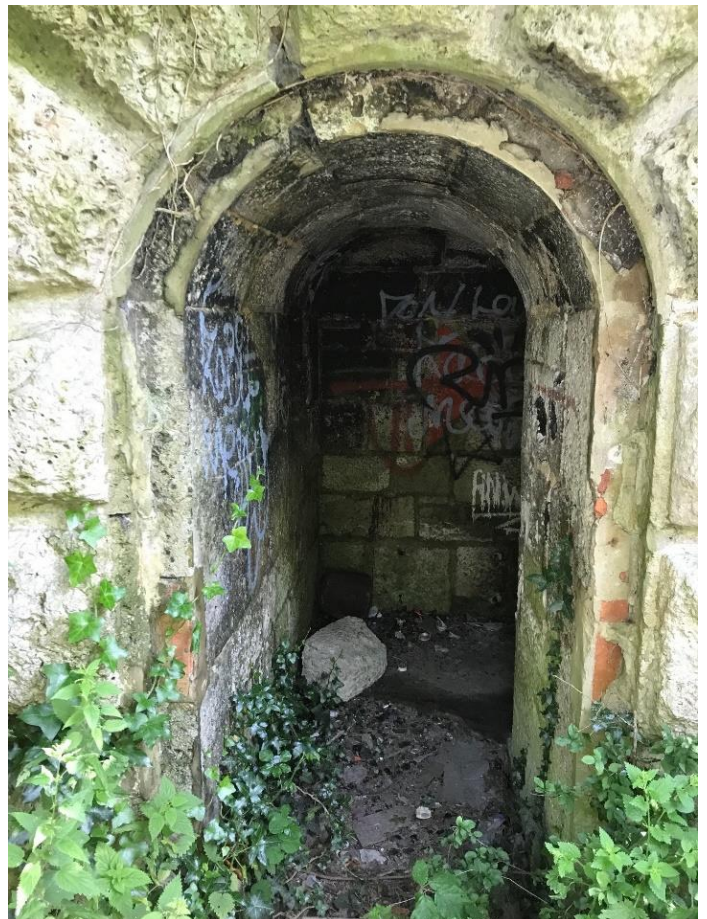
- 2.02 Within the undergrowth the masonry structure appears to remain in place and where the stonework can be reached it appears generally in reasonable condition. Access into the structures is not possible due to the presence of block infill to openings as illustrated in the image opposite.

- 2.03 It is noted that the Battery structure is formed with generally large Portland Stone blocks and is robustly built to withstand military service, however invasive vegetation still has potential to cause significant damage to the structure.

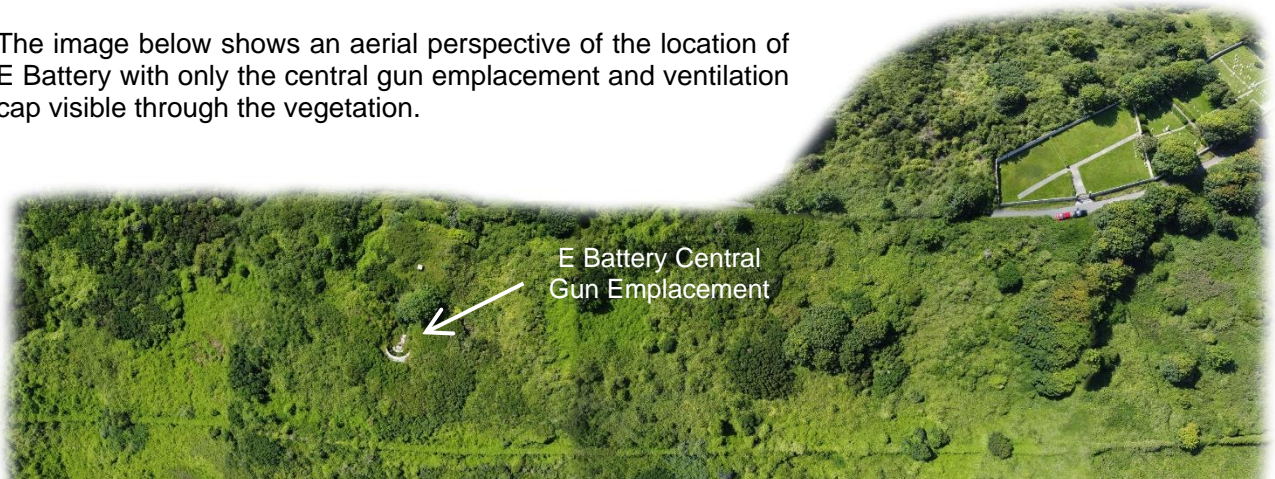
- 2.04 The image below shows an aerial perspective of the location of E Battery with only the central gun emplacement and ventilation cap visible through the vegetation.

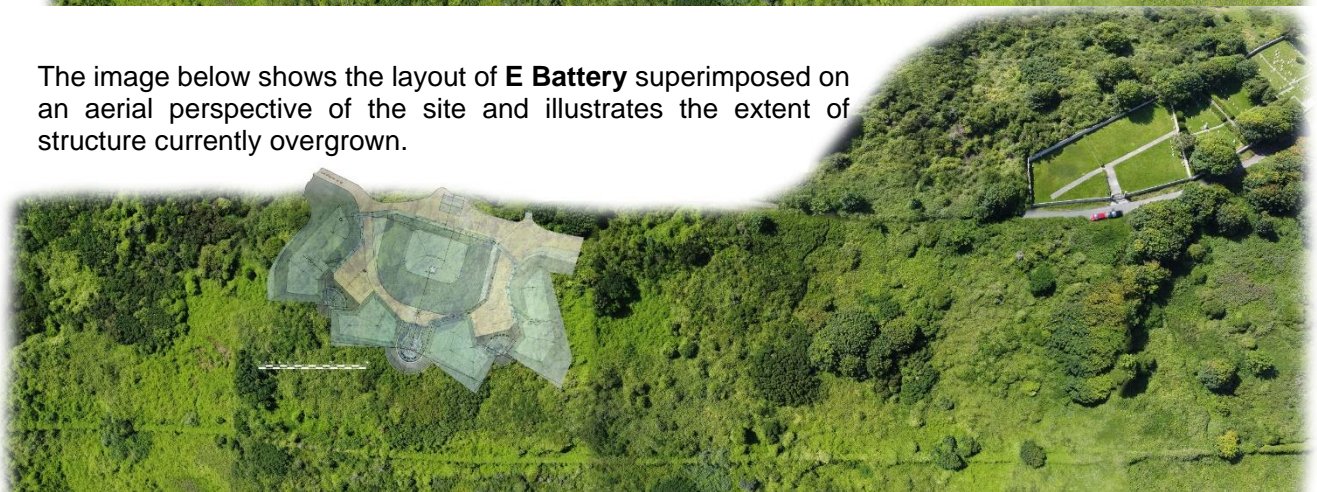
- 2.05 The image below shows the layout of **E Battery** superimposed on an aerial perspective of the site and illustrates the extent of structure currently overgrown.

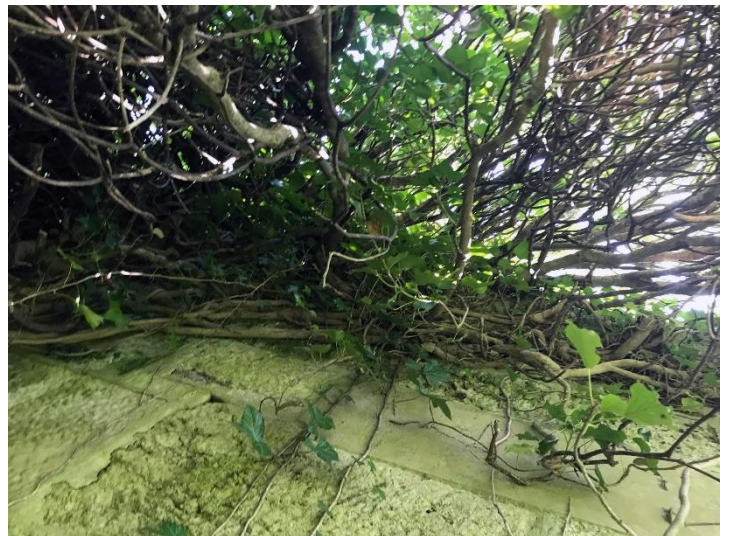
- 2.06 The image opposite illustrates the extent of vegetation that is present across the structure of E Battery. The vegetation in the image is concentrated around exposed wall heads and is a significant ongoing risk to the masonry, particularly where it is penetrating joints.

- 2.07 At this stage the majority of the structure is inaccessible for inspection but there are concerns that the high level areas are at an elevated risk of damage and vegetation should be removed at the earliest opportunity.

- 3.02 Vegetation is currently the most active and progressive risk to the monument and prompt action to control or preferably remove this risk is recommended as a matter of urgency.

- 3.06 Removal of vegetation where it is attached or embedded into the masonry is considered essential, but must follow clearly defined methodologies to ensure no long-term damage is caused to the structure. Appendix B provides Historic England guidance and appendix C guidance from Environment and Heritage Services Northern Ireland on this and should be used as a key reference documents in the development of a vegetation control/removal strategy.

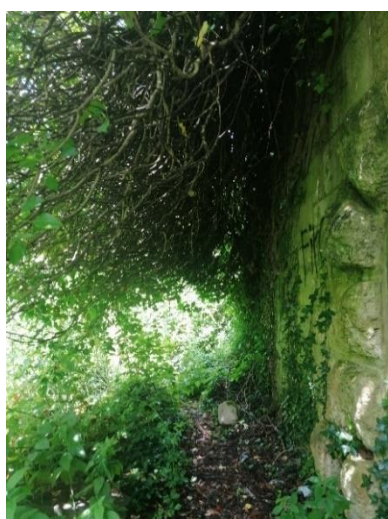
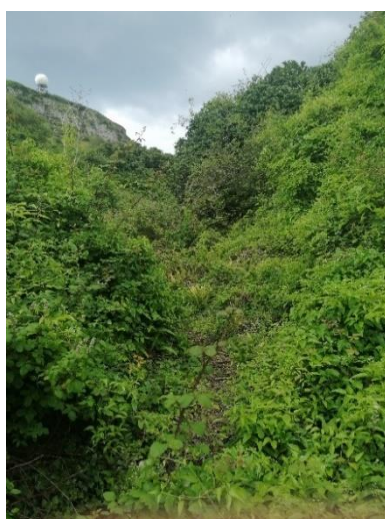
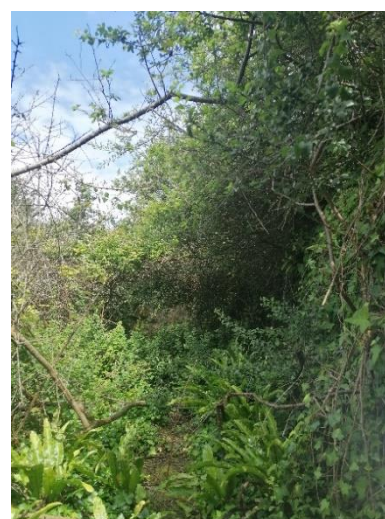
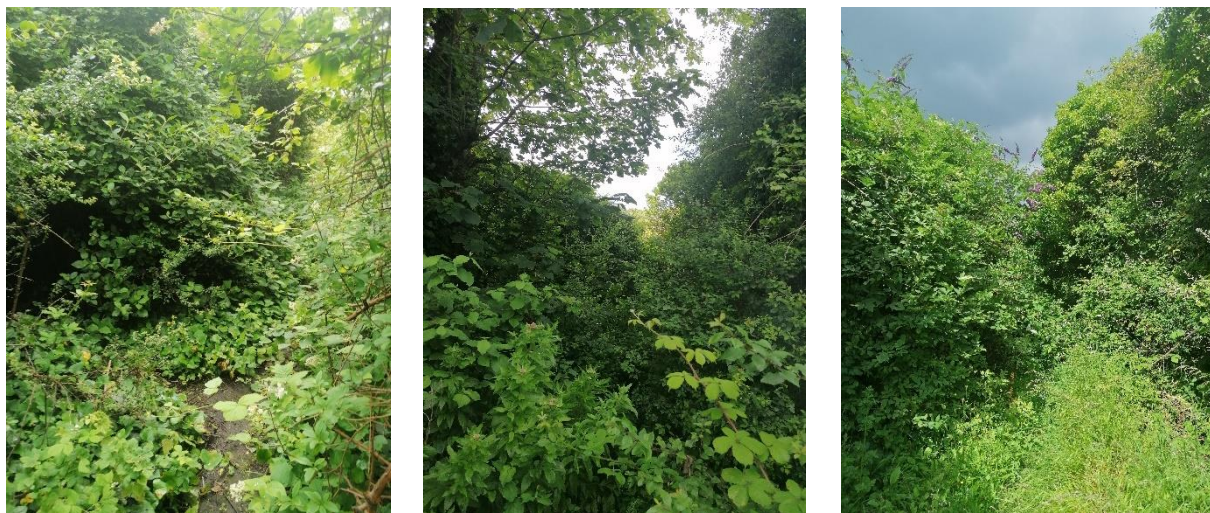
The majority of access paths and gun battery building are covered in and surrounded by dense scrub, typical of the East Weare cliffs. The scrub is dominated by blackthorn *Prunus spinosa* with abundant bramble species *Rubus fruticosus agg.* and ivy *Hedera helix ssp. Hibernica*. Dogwood *Cornus sanguinea* is frequent and wayfaring tree *Viburnum lantana*, sycamore *Acer pseudoplatanus*, clematis *Clematis vitalba* and dog rose *Rosa canina* are all occasional. The ditch in front of the gun battery building is dominated by dense ivy and bramble. Bramble scrub also dominates on the edges where scrub cannot grow into rockier areas. Nettle *Urtica dioica*, patches are found where nutrient rich slumps have formed. Where scrub growth is overhanging and leaves clearer patches beneath, some woodland specialists are established including occasional pignut *Conopodium majus* and hart's-tongue fern *Asplenium scolopendrium*.

**Photographs 1: Section of photographs of the scrub along the current partially accessible paths**

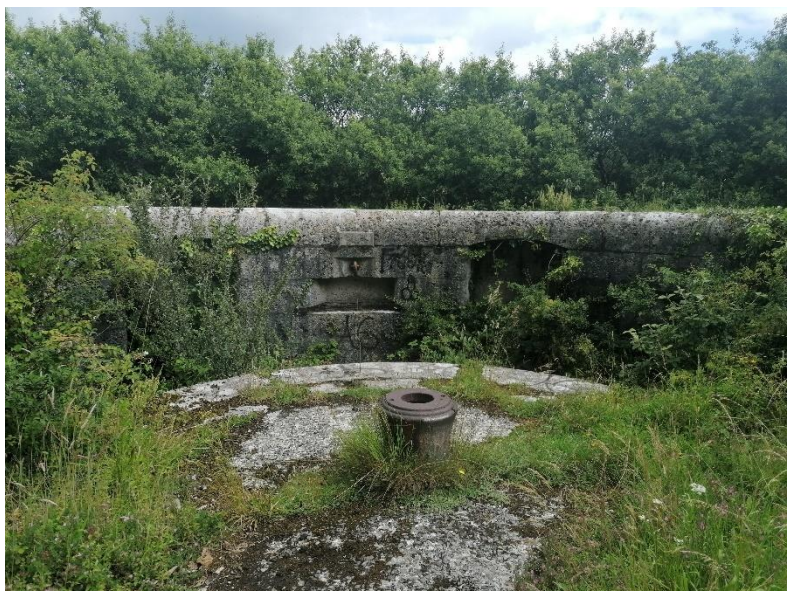
**Photograph 2: Eastern (front) gun mount showing calcareous grassland, short-perennial and diverse scrub edge habitat**

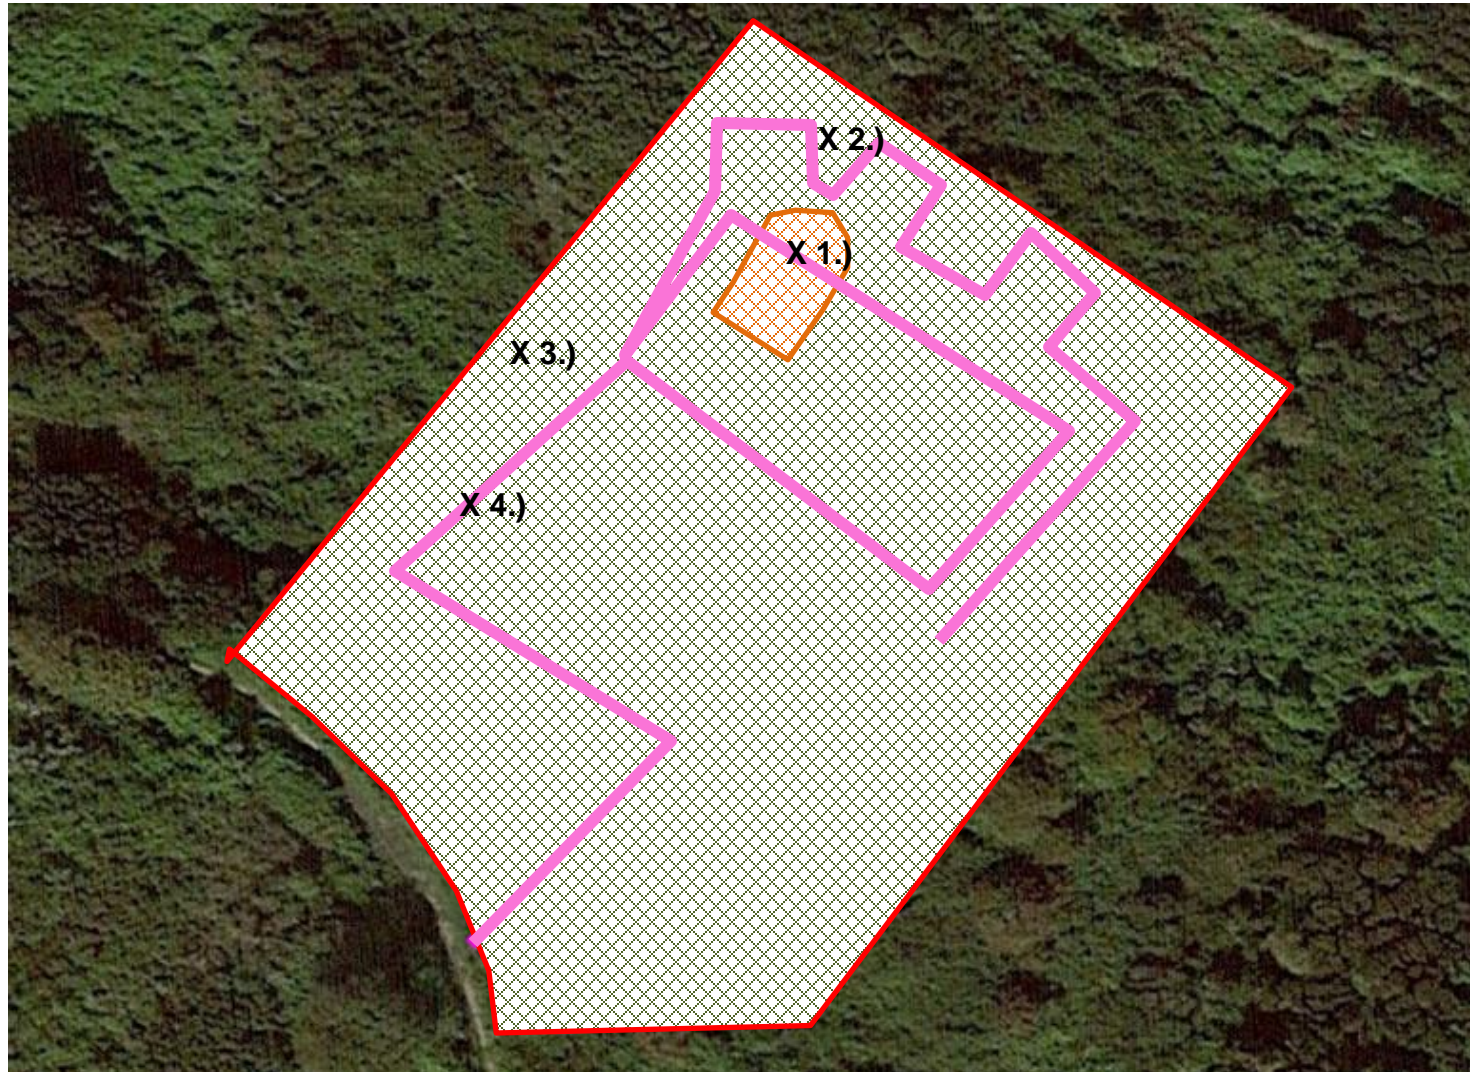
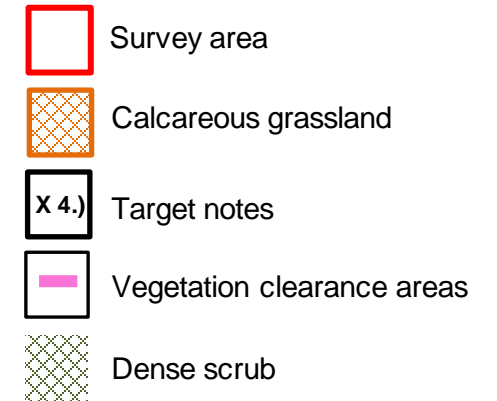
**Figure 1: Phase 1 plan with proposed clearance works overlay**

- 1.) Calcareous grassland will not require removal here as on top of gun battery structure, only scrub will be cleared in this area
- 2.) Ditch with bramble scrub and dense ivy cover
- 3.) Small area of calcareous grassland away from scrub clearance path
- 4.) Short perennial habitats present under scrub, particularly on existing pathways
