STRUCTURAL REPORT

Anchor Paddock
Batchelors Lane
Wimborne
BH21 7DS

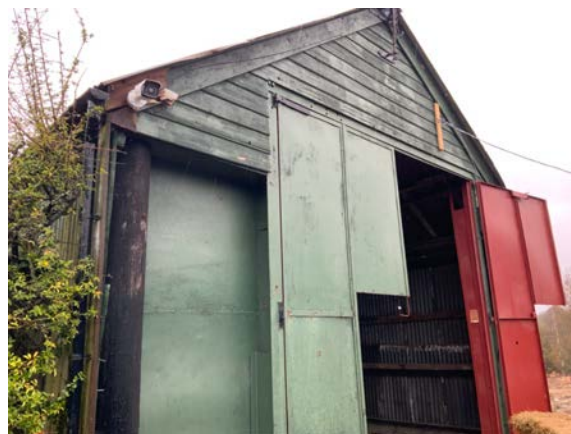
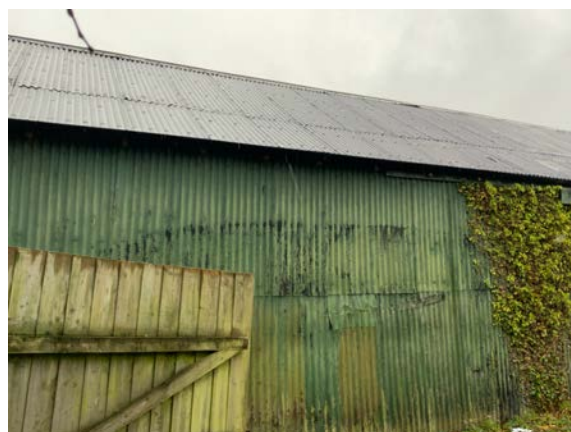
Exterior photos

The external walls and frame of the property were found to be vertically upright and sound with no sign of significant movement in the floor slab or roof structure.

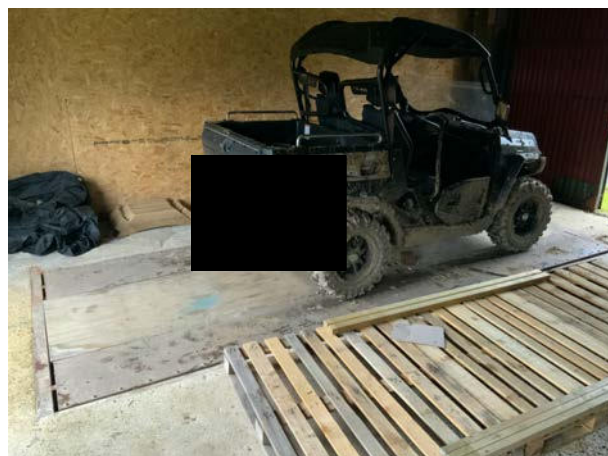
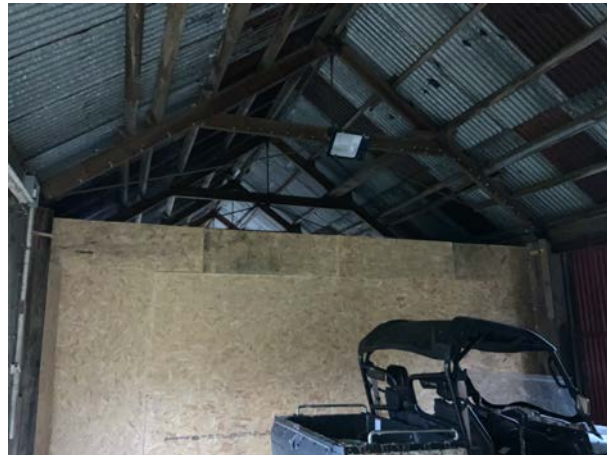
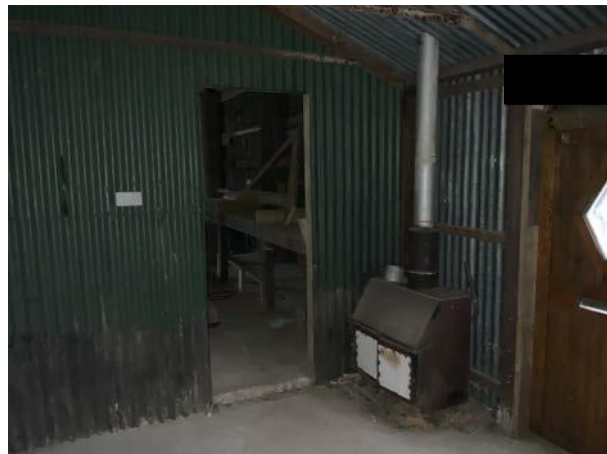
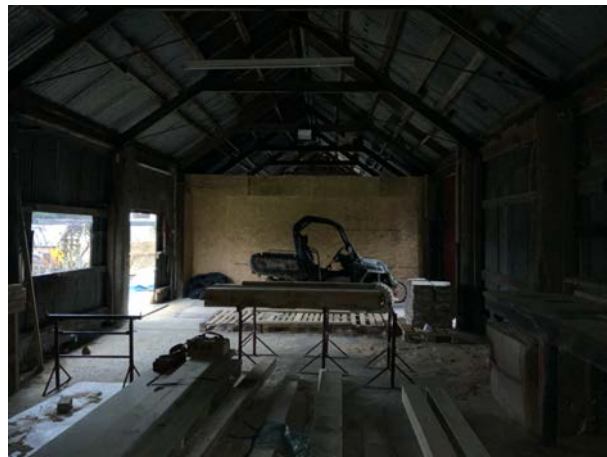
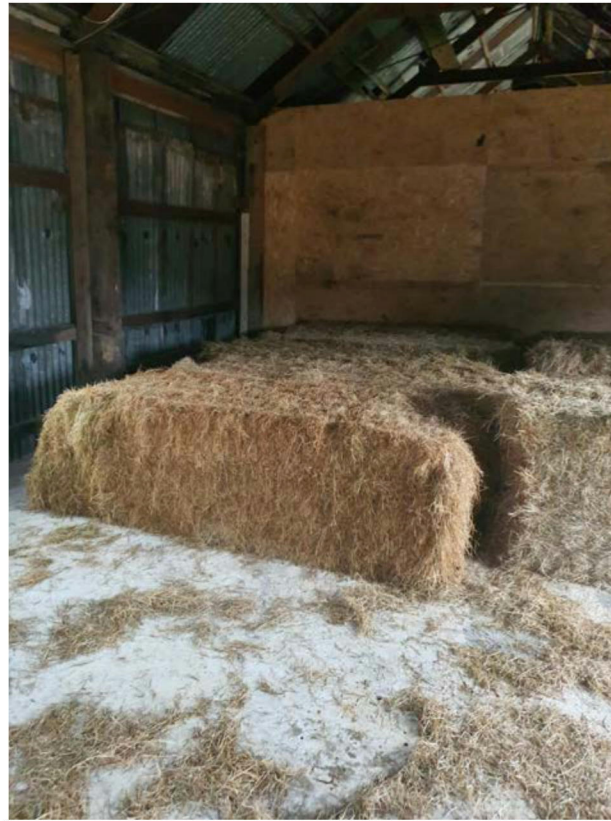
Interior photos

The concrete floor slab was also sound, where visible, and the roof showed no sign of sagging.
