STRUCTURAL REPORT

Anchor Paddock
Batchelors Lane
Wimborne
BH21 7DS

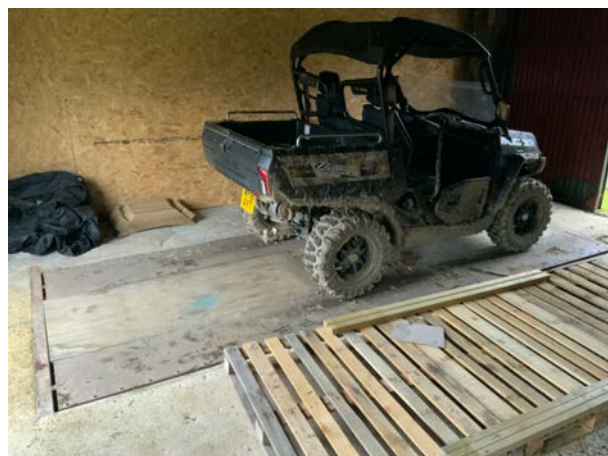
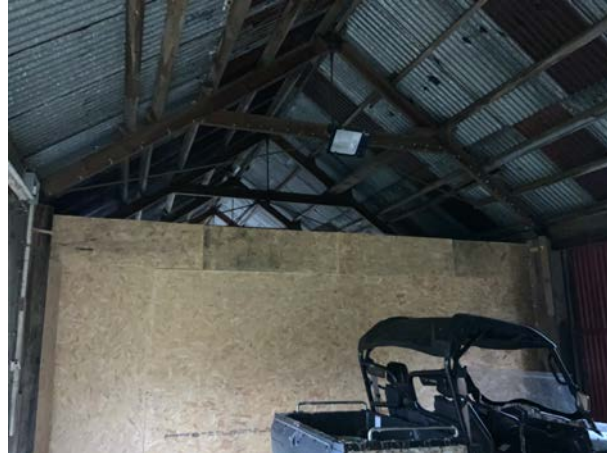
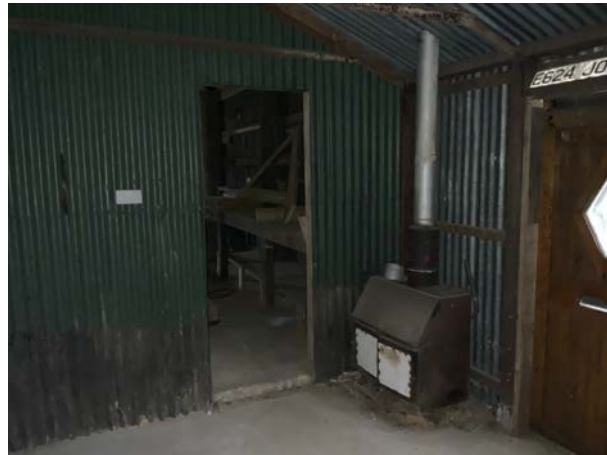
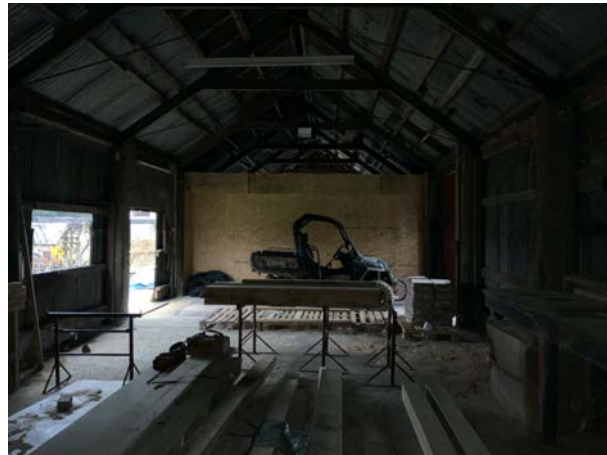
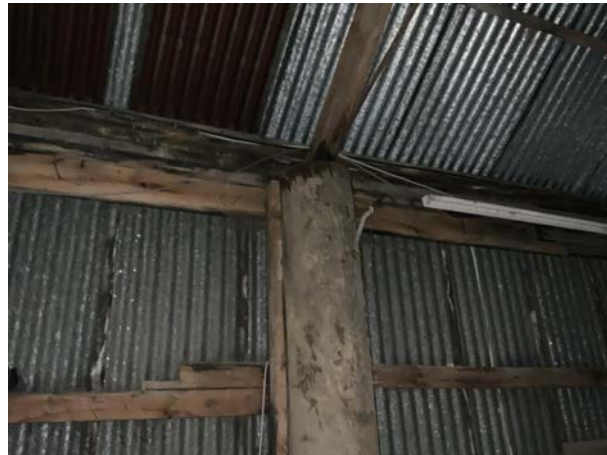
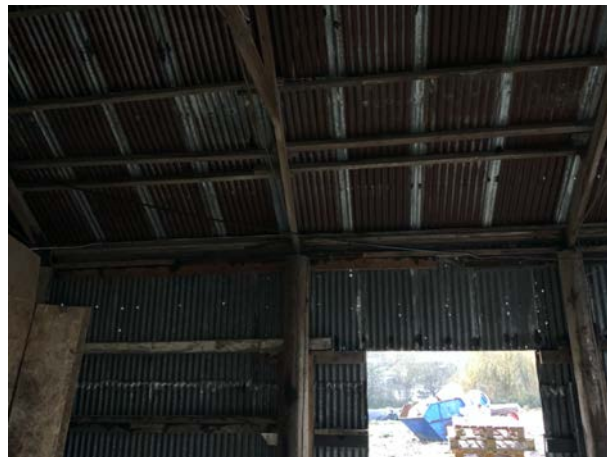
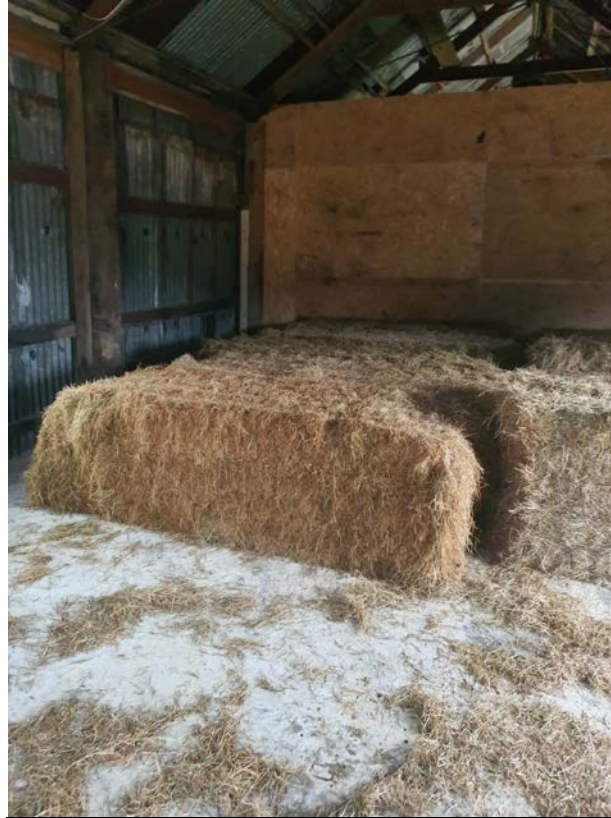
Interior photos

The concrete floor slab was also sound, where visible, and the roof showed no sign of sagging.
