# Flood Investigation Report

## Piddle Valley

7<sup>th</sup> - 8<sup>th</sup> February 2016

Report date - October 2016

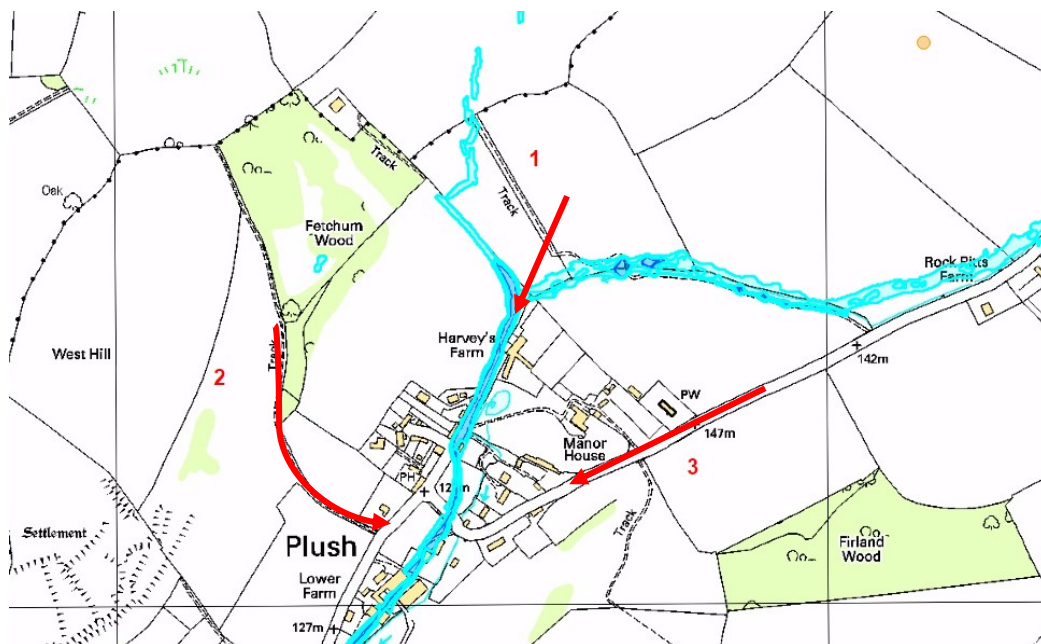
**Figure 5 - Main flow pathways in Plush**

During the evening of the 7<sup>th</sup> February, at approximately 10.30pm, residents reported hearing a ‘roar of rushing water’ just before the flash flood impacted properties within the village. The predominant flow was from the north of the village (location 1 on the map), this was due to an accumulation of surface water running off the already saturated ground within the watershed above Plush. There was not the channel capacity in Plush Brook to cope with such a high intensity of rainfall and as such the water came out of bank almost immediately causing the internal flooding of 3 properties. The brook rose by approximately 1.5m before coming out of bank again where it converged with two further surface water run-off flows as described below.

Surface water from the steep catchment to the north-east was conveyed via a bridleway known locally as Dead Cat Lane (location 2). There is a drainage system at the end of this bridleway, however due to the existing camber and the amount and rate of flow received, the surface water bypassed the inlet to the drainage system and flowed towards the village, bringing with it a large amount of mud and scalping’s from the bridleway which in turn blocked the road gullies. Surface water was also conveyed down into the village from the from the north east, via the C97 road (location 3), the large volumes of water were unable to enter the highway drainage systems effectively resulting in a combination of fluvial and surface water flooding to 3 properties in the centre of the village. A further property internally flooded as a result of surface water run-off from an adjacent field.

As part of the investigation process it will be recommended to investigate the potential restrictions to flow within Plush Brook, to divert surface water away from the village at Dead Cat Lane and for DCC Highways to repair any faults within the highway drainage through their recent review of the infrastructure here, see Section 6 for further details.

| Action By | Recommended Action | How |
|---|---|---|
| <b>LLFA, DCC Highways, Rights of Way/ Landowner</b> | To investigate diversion of surface water from Dead Cat Lane away from the centre of Plush | Review options with landowners and Rights of Way. |

| <b>LLFA/Riparian Owners/Landowners</b> | To keep Plush Brook channel clear of obstructions | To work with property owners and land owners to remove any potential obstruction and to increase maintenance of Plush Brook |
| <b>DCC Highways</b> | To ensure efficient operation of highway drains on the C97 | To repair broken pipework found. |

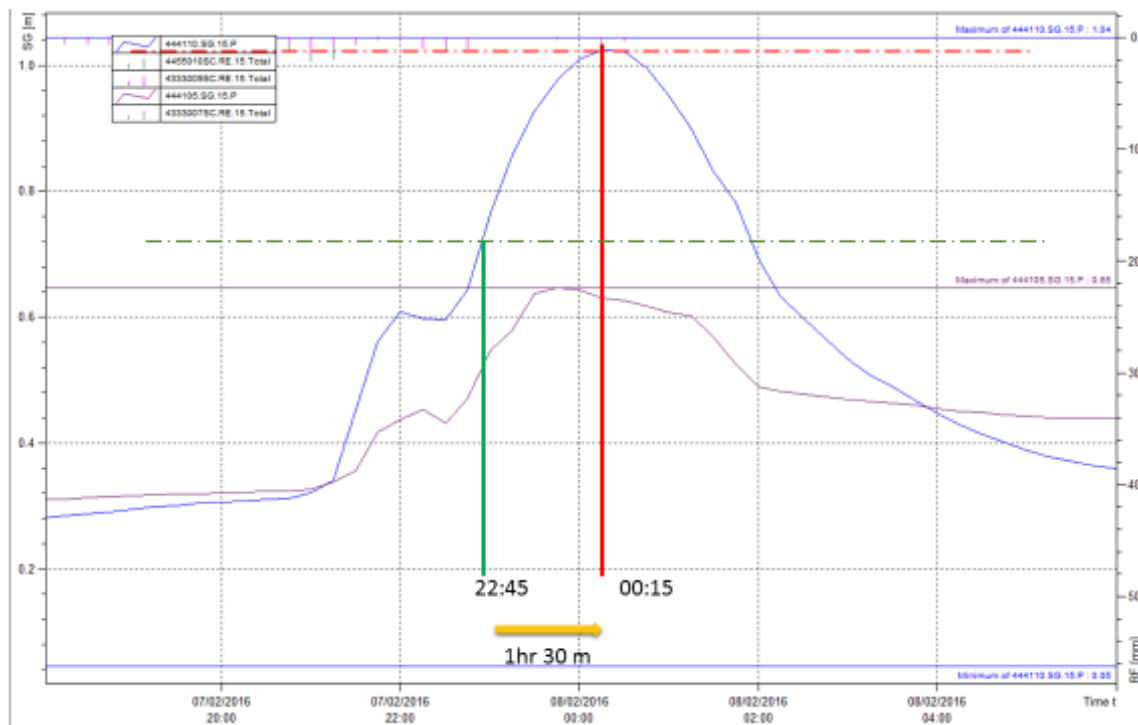
**Figure 6 - New Flood warning threshold level for Piddletrenthide**

During the 7<sup>th</sup> February Piddletrenthide was hit by Storm Imogen at approximately 10.30pm. Properties were flooded as a result of surface water run-off from adjacent fields and Main River flooding. There were no flood warnings issued due to the very localised and short intensity of the rainfall event, however the EA have now reviewed their flood warning level and lowered the trigger level from 1.04m to 0.65m in order to provide a longer lead in time in the event of flooding.

| Quick wins |
|--|
| <ul style="list-style-type: none"> <li>The EA have changed the flood warning threshold level for the River Piddle to offer more time to prepare in the event of flooding.</li> </ul> |

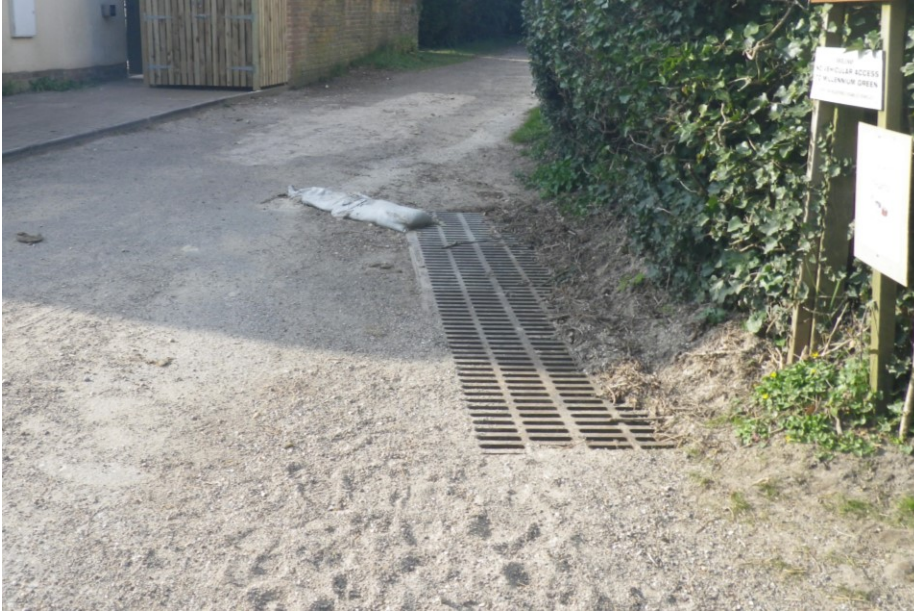
**Figure 9 - Entrance to Drainage System in West lane, Piddlehinton**

The majority of surface water from West Lane, missed the main inlet to the FAS and flowed onto Rectory Road. Recommendations have been made to explore whether the grill in West Lane (see figure 9 below) can be modified to allow more surface water into the existing drainage system as residents are currently having to divert water using sandbags during a flood event.

| <b>LLFA, Rights of Way, DCC Highways</b> | To improve surface water drainage in Rectory Road | To explore whether the entrance to West Lane in Rectory Road, Piddlehinton, can be modified to allow more surface water into the existing drainage system. |
