**IN THE MATTER OF AN APPEAL UNDER SECTION 174 TOWN AND COUNTRY
PLANNING ACT**

LAND Anchor Paddock, Batchelors Lane, Holtwood, Holt, Dorset, BH21 7DR

PROOF OF EVIDENCE OF Nikki Taylor

- 2.1 On 20th December 24 I went to Anchor Paddock, Batchelors Lane, Holtwood, Holt, Dorset, BH21 7DR to conduct a Preliminary Bat Roost Assessment on a range of outbuildings. The buildings inspected are illustrated in Appendix A, page 9.

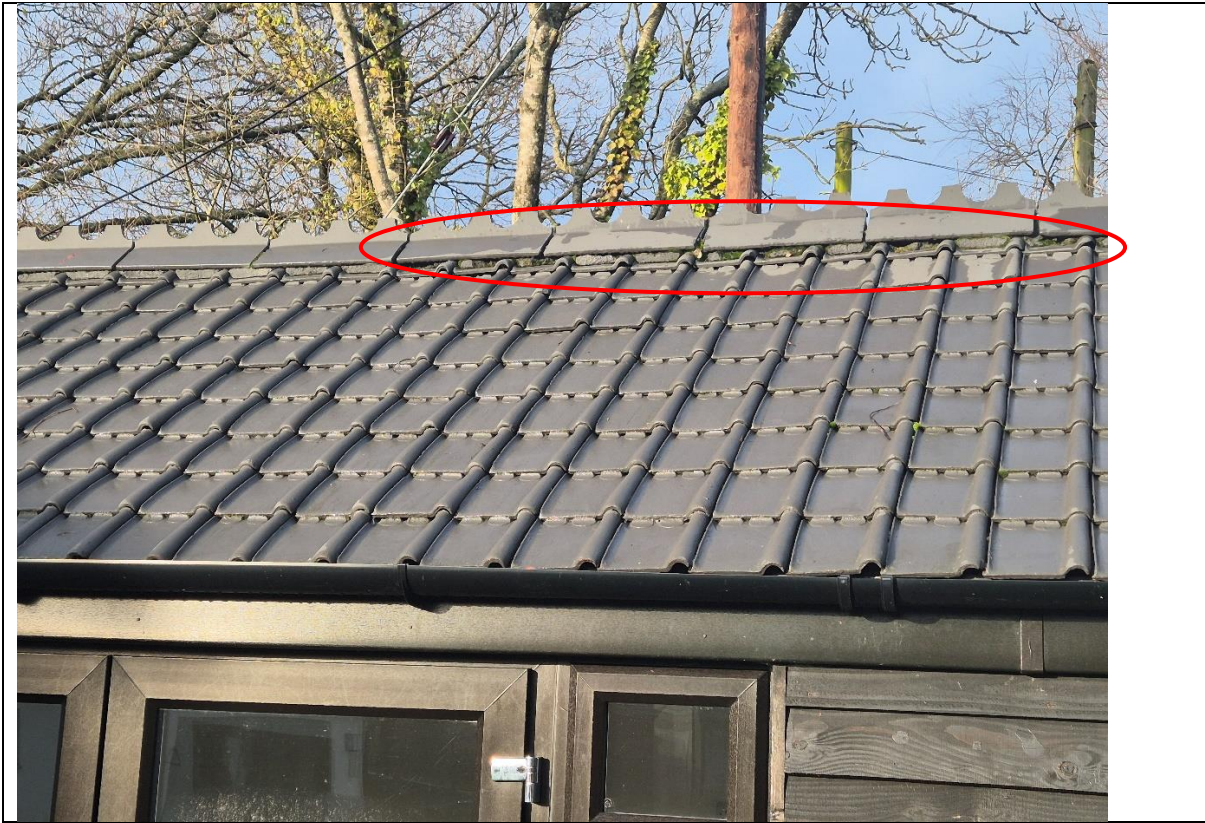
- B. On the front elevation, gaps along the ridge line formed by missing mortar and some partially lifted tiles may be used during summer months due to the roof orientation. However, the gaps appear to be limited in extent. As a result, these gaps will not be used by large numbers of bats or for regular roosting or maternity purposes during the summer.

Front elevation (south-east facing)

- 4.3 Based on my survey findings, the limitations to the survey and taking into account the guidelines, it is my view that whilst additional phase 2 emergence survey is not required, precautionary mitigation measures should be put in place for Building 1 and carried out prior to any demolition work. These measures should include a pre-works endoscopic inspection of all PRFs, and a destructive inspection of the internal void by a suitably licenced ecologist. Depending upon the results of the additional inspections, the dismantling of PRFs may need to be undertaken by hand and supervised by a suitably licenced ecologist. It should be noted that if bats or evidence of bats, are found during the pre-works inspections or at any time during the works themselves, all work should stop, and Natural England contacted for advice before proceeding. In these circumstances, a European Protected Species Mitigation Licence granted by Natural England would likely be required.

- 4.4 Given the low potential of Building 1 to be used by roosting bats, it is my advice that this building can be given consent to be demolished under the planning regime subject to the above further precautionary pre-works inspection which can properly be secured by condition/s106 obligation.

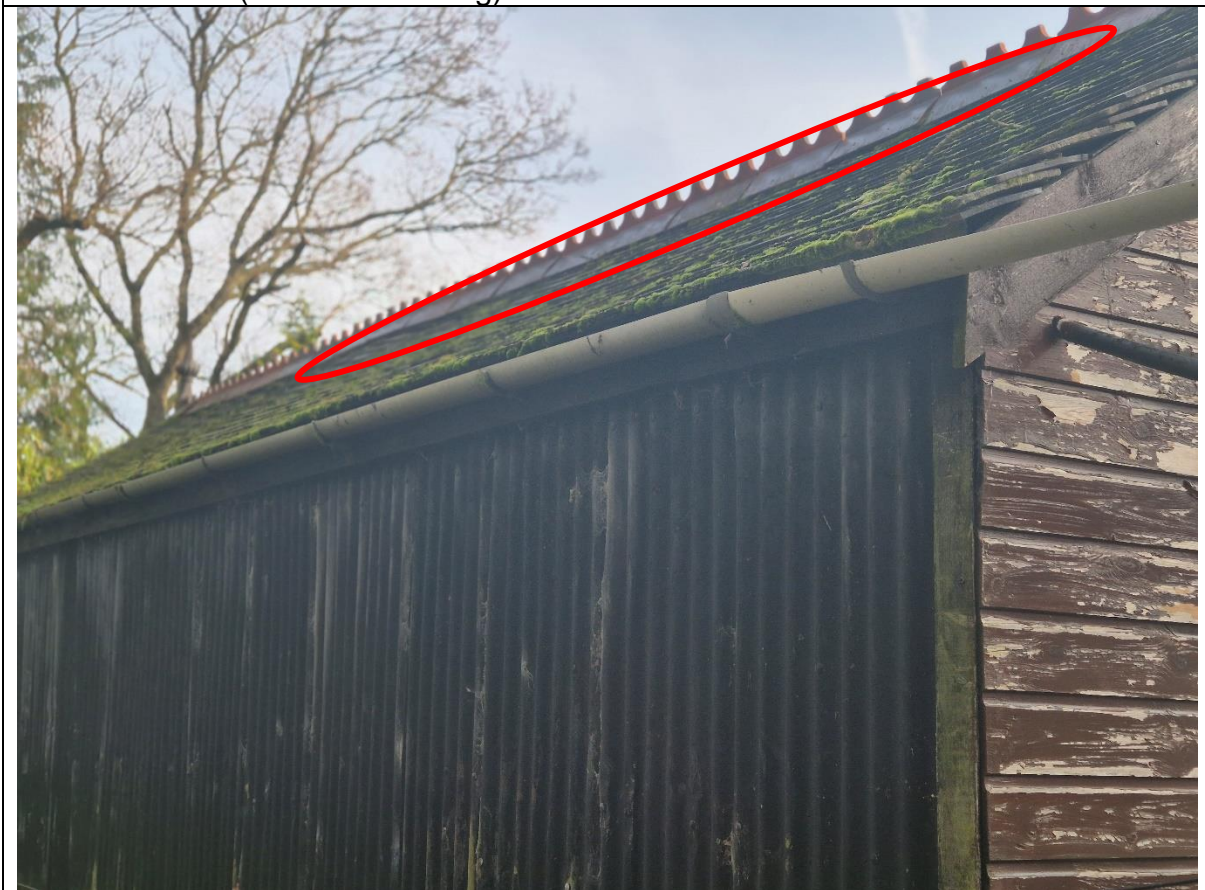
- 2.7 The gaps recorded during the survey align with this classification as follows:
- A. The rear elevation and south-west gable are shaded and will be cooler such that gaps noted on these aspects offer some winter roosting habitat but do not qualify as a classic hibernation site such as a cave or underground structure that offer extensive roosting space and stable conditions. Therefore, whilst individual bats could use the gaps on these aspects of the building opportunistically, they neither offer enough space or stable conditions that are required for full hibernation use and are unlikely to be used during the summer months when warm spaces are required by bats during their active season.

Rear elevation (north-west facing)

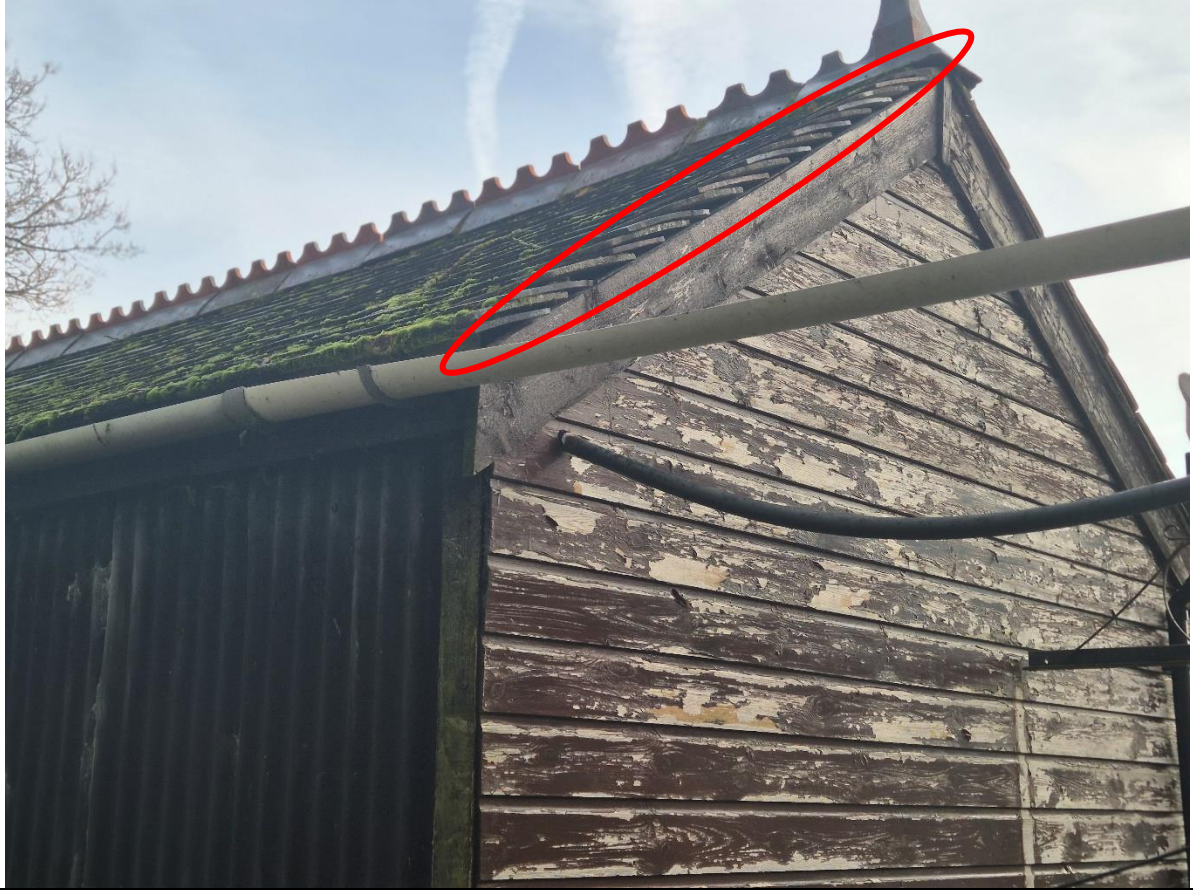
Gable end (south-west facing)
