ROAVR | GROUP

*This Report is the copyright of Woodland Solutions Northern Limited t/a ROAVR Group.
Any unauthorised reproduction or usage by any person other than the addressee is strictly prohibited.*

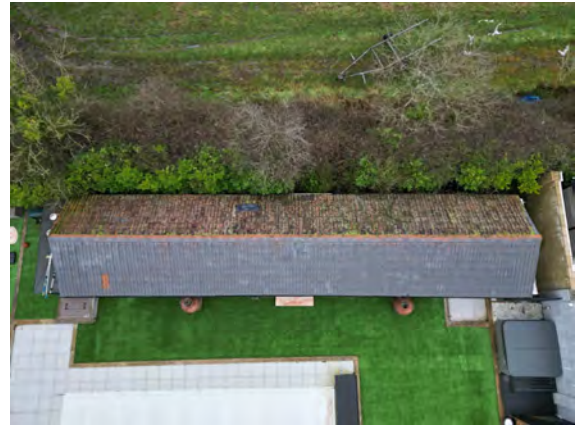
<i>Detail</i>	<i>Photograph</i>
<i>Southern elevation of B1</i>	 
<i>Western elevation of B1</i>	 
<i>Eastern elevation of B1</i>

Aerial view of B1

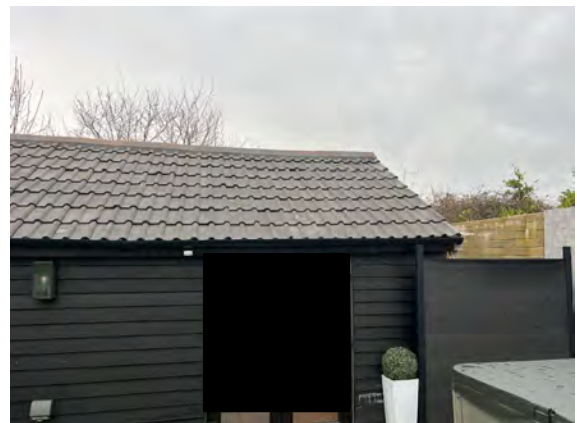
The roof, constructed from tightly fitted grey clay tiles capped at the gable ends with lead flashing, appears sound, leaving no discernable voids or lifted tiles. With no loft or internal void space present and the condition of the roof free from gaps or defects, the ecological potential for bats is considered **negligible**.

General roof condition of B1
