Portland  
energy recovery  
facility

Framework heritage  
mitigation strategy

E Battery  
East Weare  
Portland  
Dorset

Prepared by: Jon Avent  
*BSc(Hons) MStructE, IHBC, CARE  
Accredited Conservation Engineer*

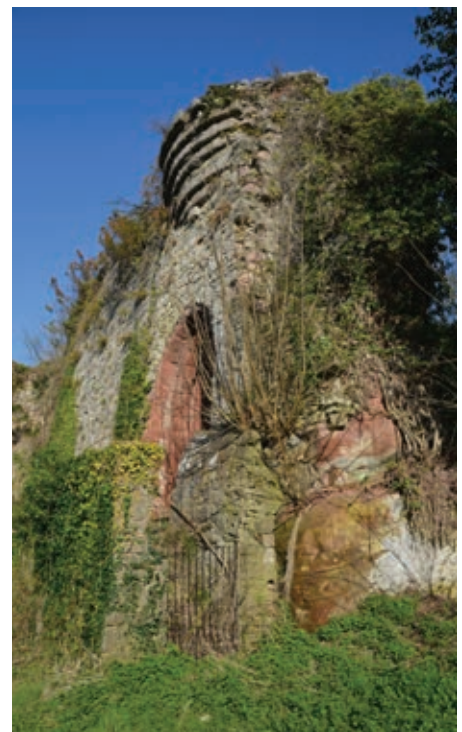
**Figure 9**  
Intrusive vegetation at Ruthin Castle

Such intrusive vegetation will require careful pruning to reduce wind resistance, taking care not to damage historic fabric or cause collapse during the process. **Figure 9** shows the curtain walls at Ruthin Castle, Wales, affected by intrusive vegetation.

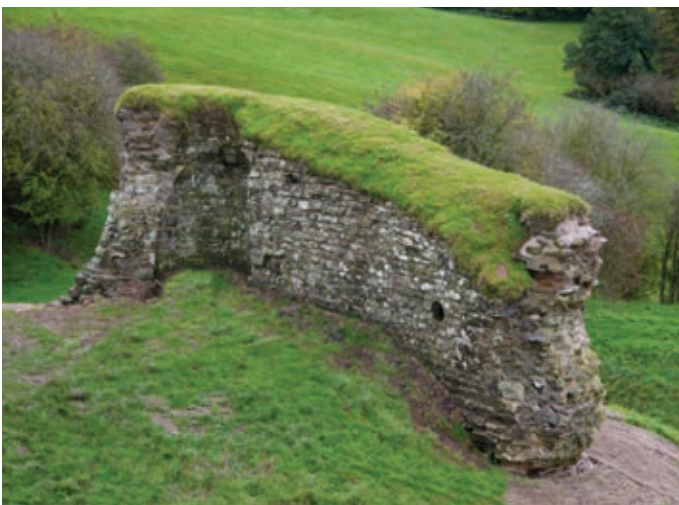
**Figure 10**  
Soft capping works at Kilpeck Castle

In recent years there has been a move towards 'soft capping' ruined walls, using turf sourced local to the ruin. **Figure 10** shows recently completed soft capping works to masonry remains at Kilpeck Castle, Herefordshire. The turf capping absorbs water and insulates the wall head, and can also 'breathe' and dry out. The grass overlapping the edges also provides a natural 'drip', protecting wall faces. The technique also has the advantage of retaining a soft and natural appearance to the ruin.

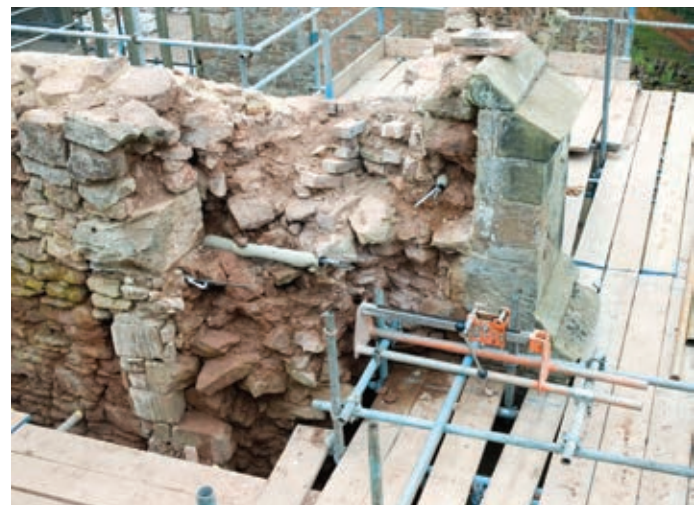
**Figure 11**  
Stitching of fractures

stainless steel ties or other forms of stitching (Figure 11), other defects may require greater consideration. It is essential that any defect is fully understood before the solution is proposed.

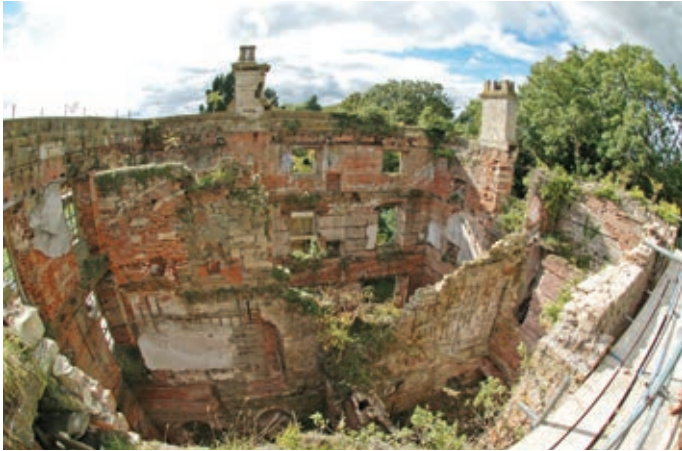
← Figure 12  
Ruins of  
Piercefield House  
showing wide array  
of openings

These pose a range of challenges and have the added risk of potentially significant collapse if failure occurs. Figure 12 shows the ruins of Piercefield House in south Wales and illustrates a vast array of window openings all potentially contributing to instability of the elevations. Where timber lintels or heads have rotted away, it may occasionally be appropriate to reinstate them if they can be protected from decay. Often the natural arching effect of historic masonry can be considered, and in some instances the failure of a door or window head does not lead to further instability in the short term. Where concerns do exist, it may

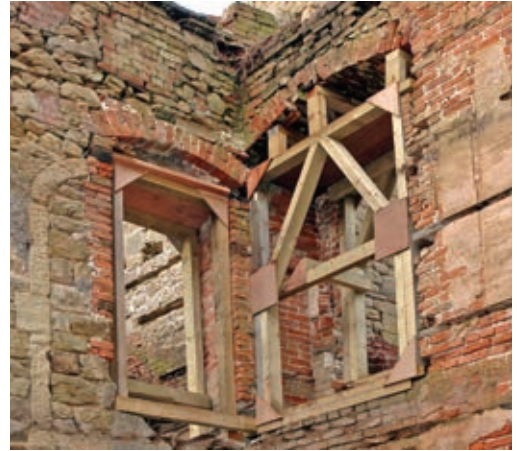
→ Figure 13  
Timber and  
ply braced frame  
in door openings at  
Piercefield House

be appropriate to implement urgent support to prevent progression of movement, pending a more permanent solution. Figure 13 shows a simple timber and ply braced frame inserted in a pair of door openings at Piercefield House.
