STRUCTURAL REPORT

Anchor Paddock
Batchelors Lane
Wimborne
BH21 7DS

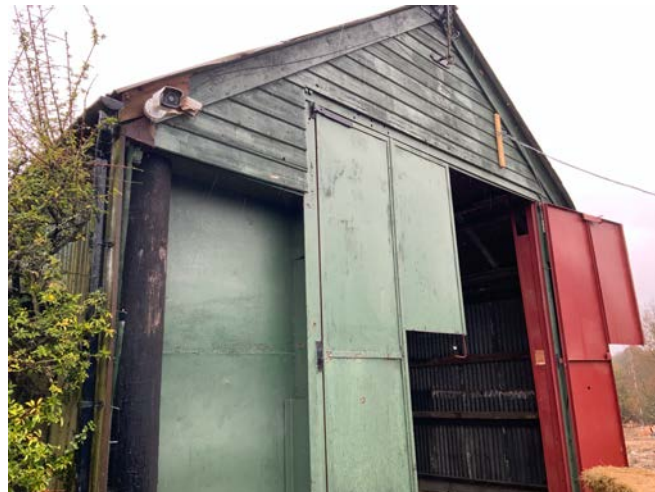
The property is an open plan timber frame barn with corrugated sheet wall cladding and a corrugated tin roof.

The external walls and frame of the property were found to be vertically upright and sound with no sign of significant movement in the floor slab or roof structure.
